F960965NU

CERAMIX BLUE
A 5650 ..

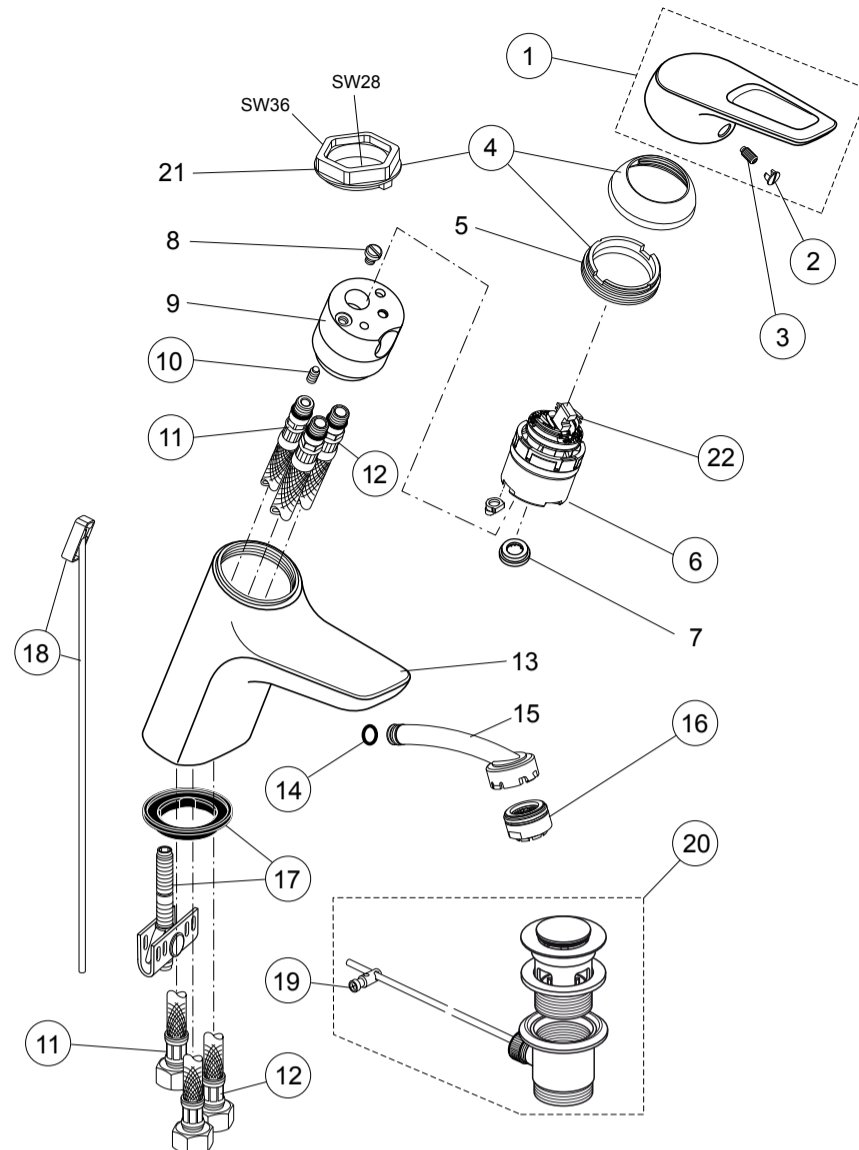
| 1 | A 963313 AA | 6 | A 861156 NU | 14 | A 961118 NU | 19 | A 963404 NU |
| 2 | A 963054 NU | 10 | A 963309 NU | 16 | A 963681 AA | 20 | A 961230 AA |
| 3 | A 963309 NU | 11 | A 963680 NU | 17 | A 960949 NU | 22 | A 861181 NU |
| 4 | B 960862 AA | 12 | A 963679 NU | 18 | A 963357 AA | | |

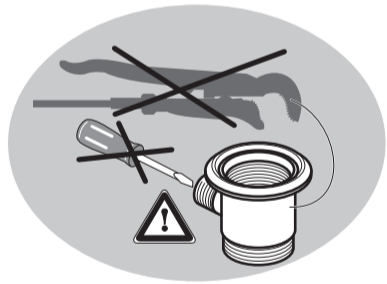
Es ist systembedingt, daß während der Aufheizzeit Wasser durch Ausdehnung am Auslauf abtropft. Dieser freie Austritt verhindert einen Druckanstieg im Speicher. Es darf deshalb niemals der Auslauf verschlossen werden. Der Einbau eines Luftsprudlers oder Schlauches mit Strahlregler ist nicht zulässig. Der im Batteriekörper eingebaute Durchflußbegrenzer macht die Armatur unabhängig vom vorhandenen Wasserdruck. Einregulieren der Wassermenge ist nicht erforderlich. Der Durchflußbegrenzer darf nicht entfernt werden!

As the water heats up, it will expand & possibly discharge through the outlet. This water discharge is normal to prevent pressure damage to the hot water vessel. DO NOT close this outlet. Aerator or hose with flow-straightener should not be used either. The built in flow limiter regulates the supply water pressure, therefore it is not necessary to use other regulating devices to control the flow. DO NOT remove the flow limiter!
